APD Noise on the Far Detector

R.J. Tesarek
7/16/13

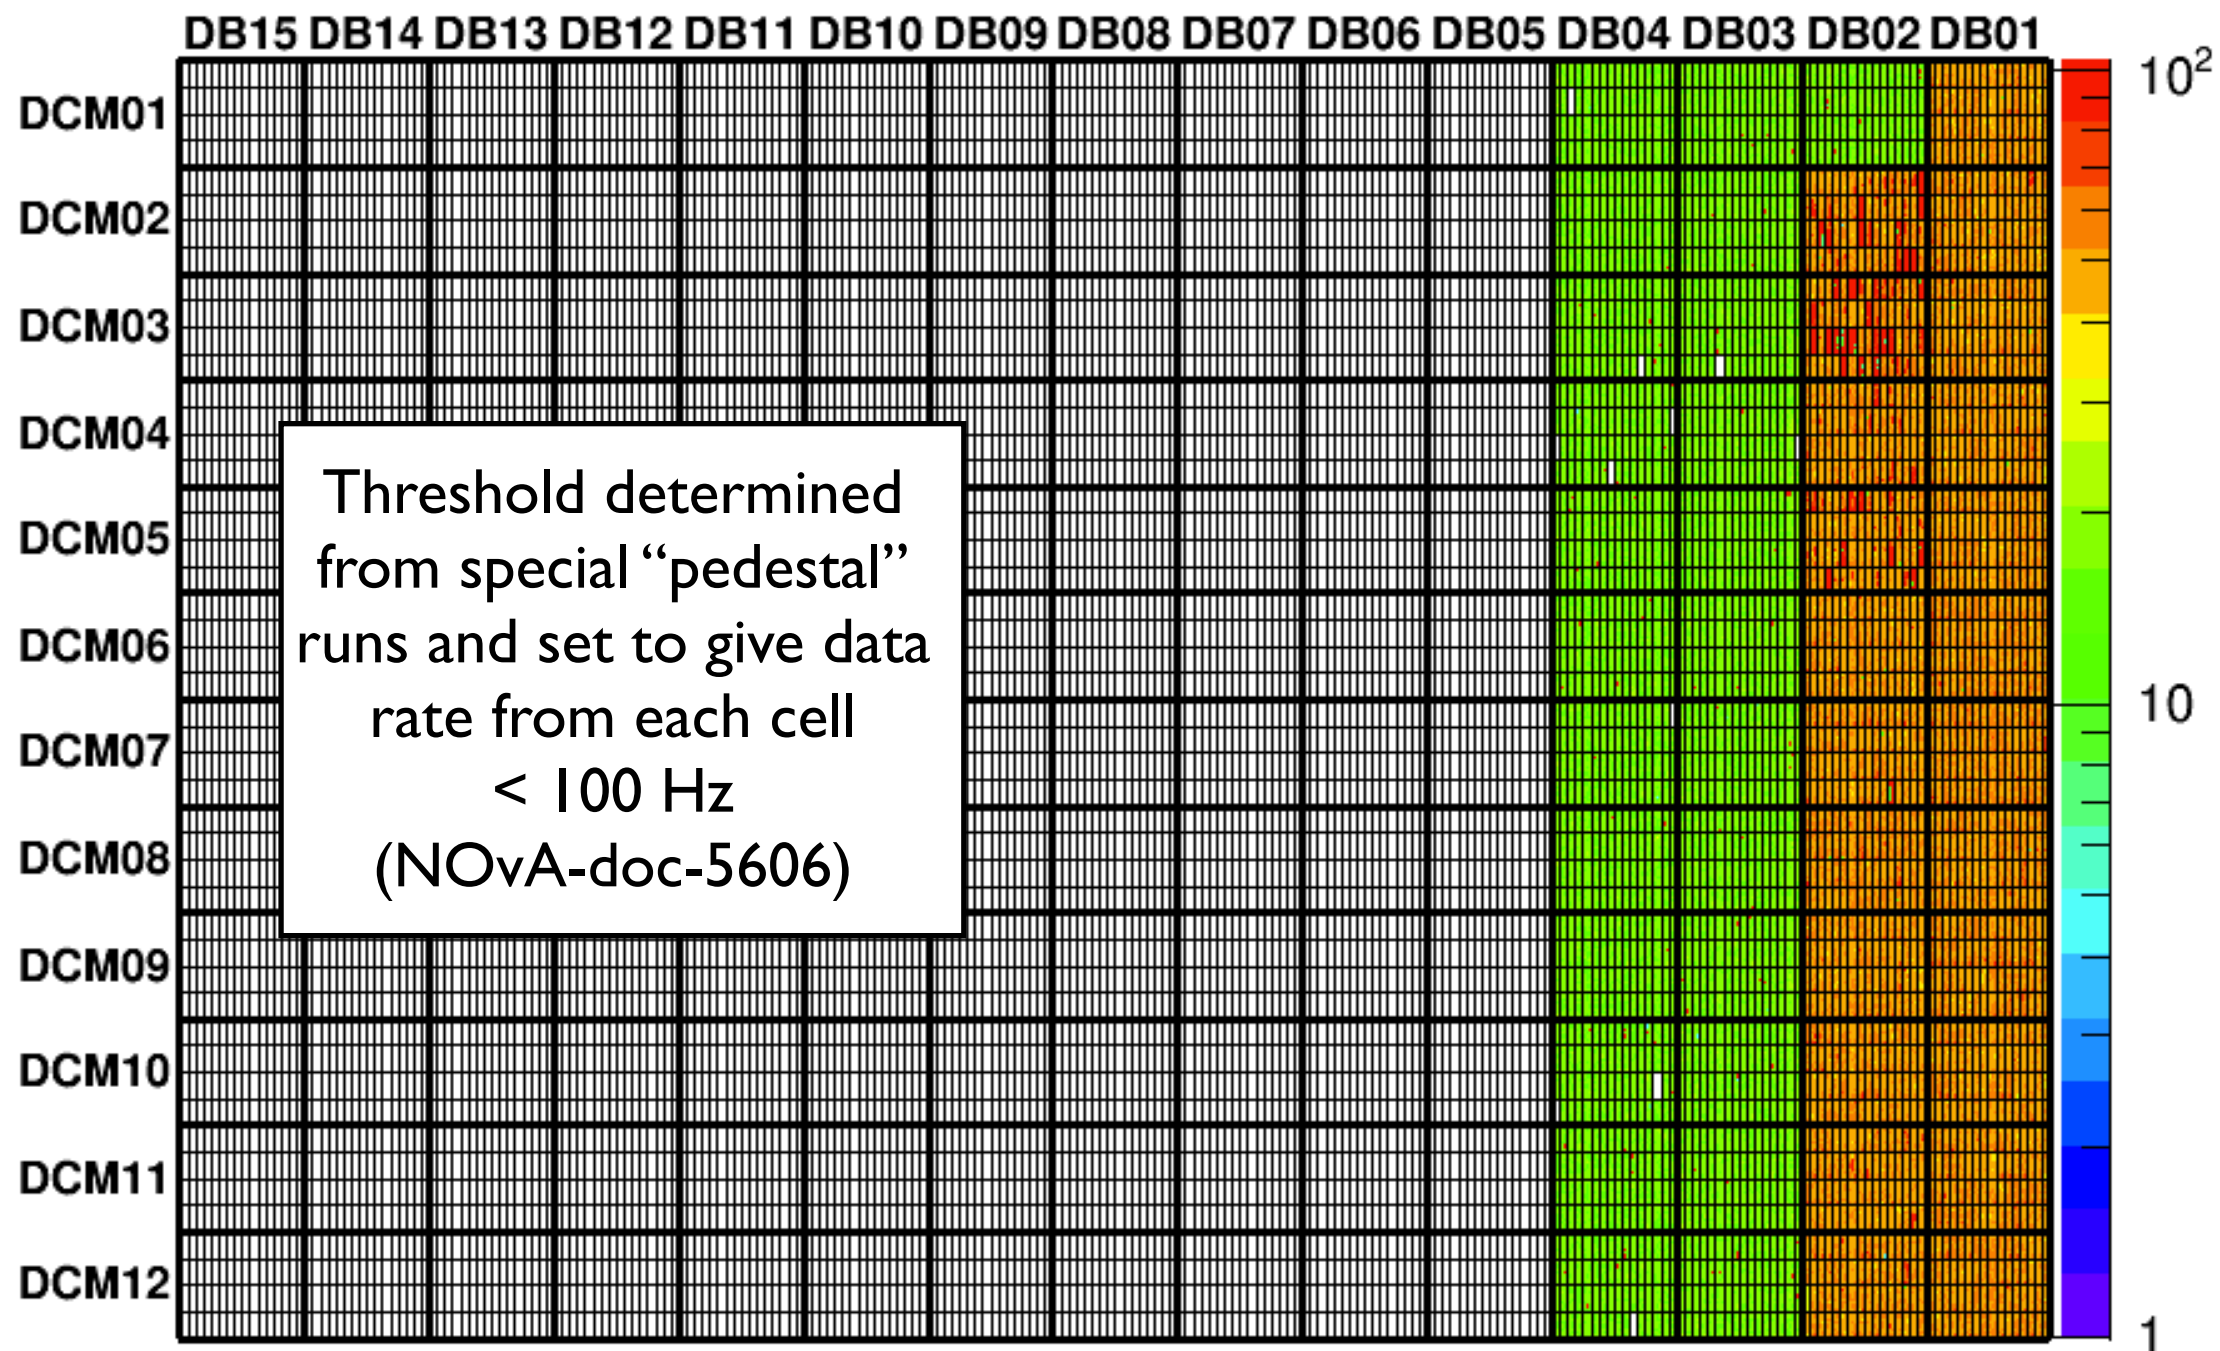
Pixel Readout Thresholds

- ~1 di-block (768) APDs installed before 5/20 have initial and continued performance good
- ~1 di-block (768) APDs installed after 5/20 following same installation and checkout procedures show:
 - ➡ Pass QA tests prior to installation
 - ➡ Higher hit rates (noise) at the nominal bias voltage
 - ➡ Higher readout threshold
 - ➡ Larger and increasing data rates
- “Training” APDs with high hit rates appears to help (not understood)
- APD “training”:
 1. Start with lower bias voltage (300V)
 2. Hold until data rates stabilize
 3. Raise bias voltage 25V and repeat 2. above until nominal bias voltage achieved
- ➡ We do not understand the need for training some of the APDs, what changed to cause this or the long term effects

Note: each black box represents 64 APDs (2048 channels)

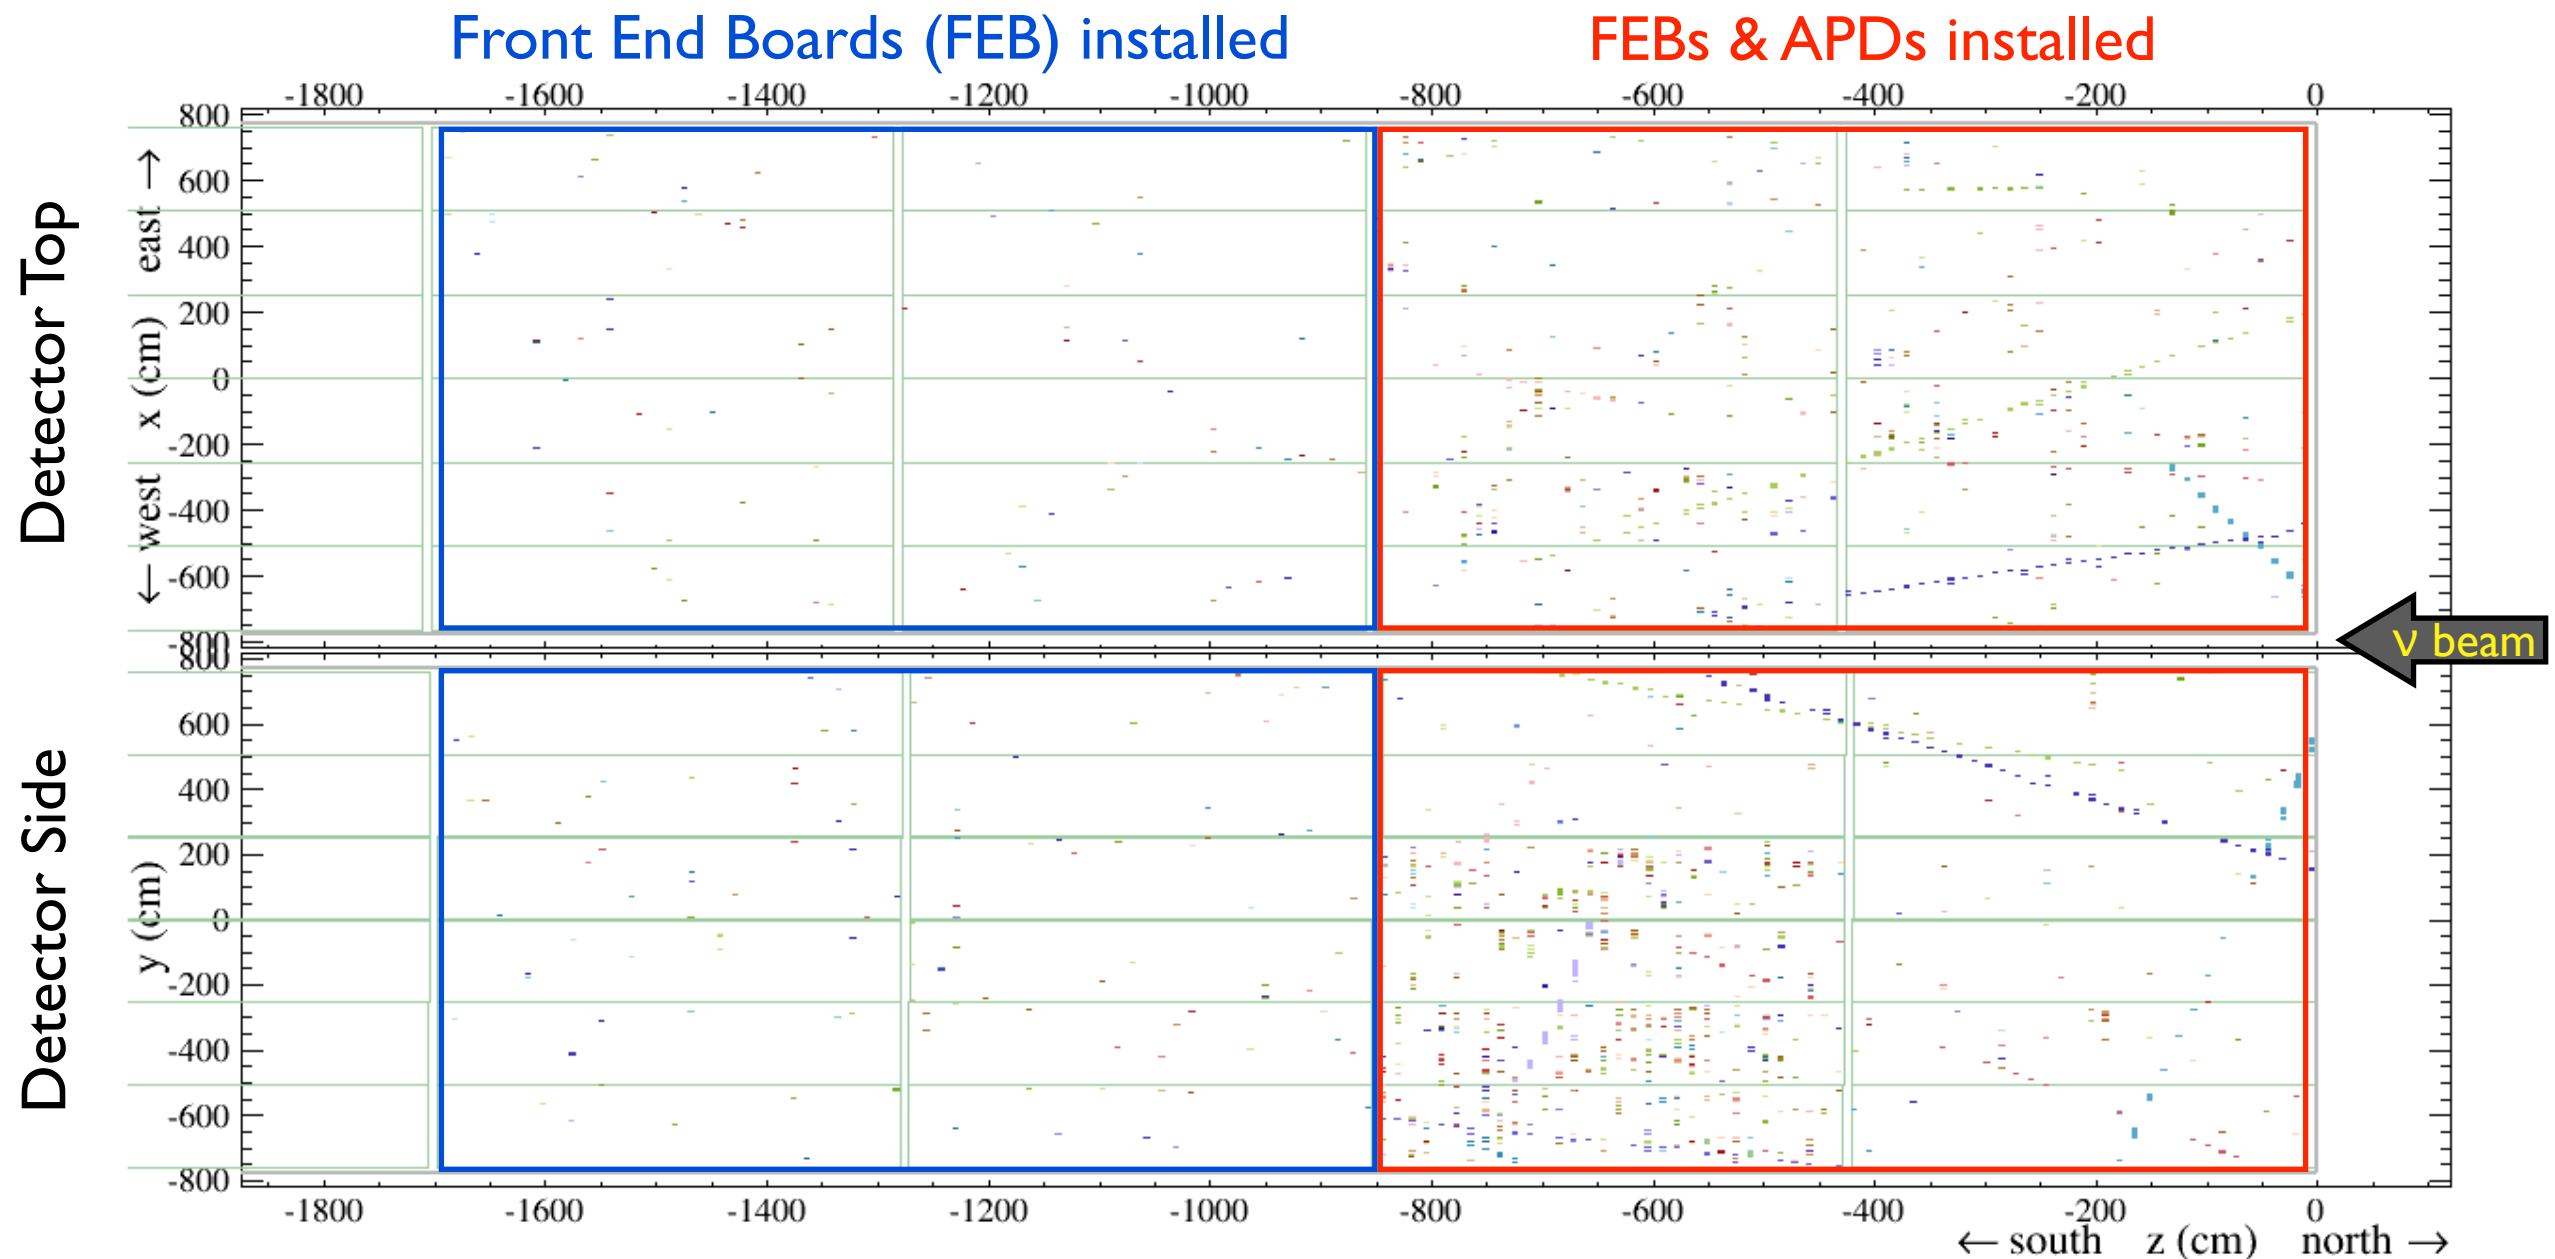
Noise Example

Note: Each green box above represents 64 APDs installed (2048 detector channels)

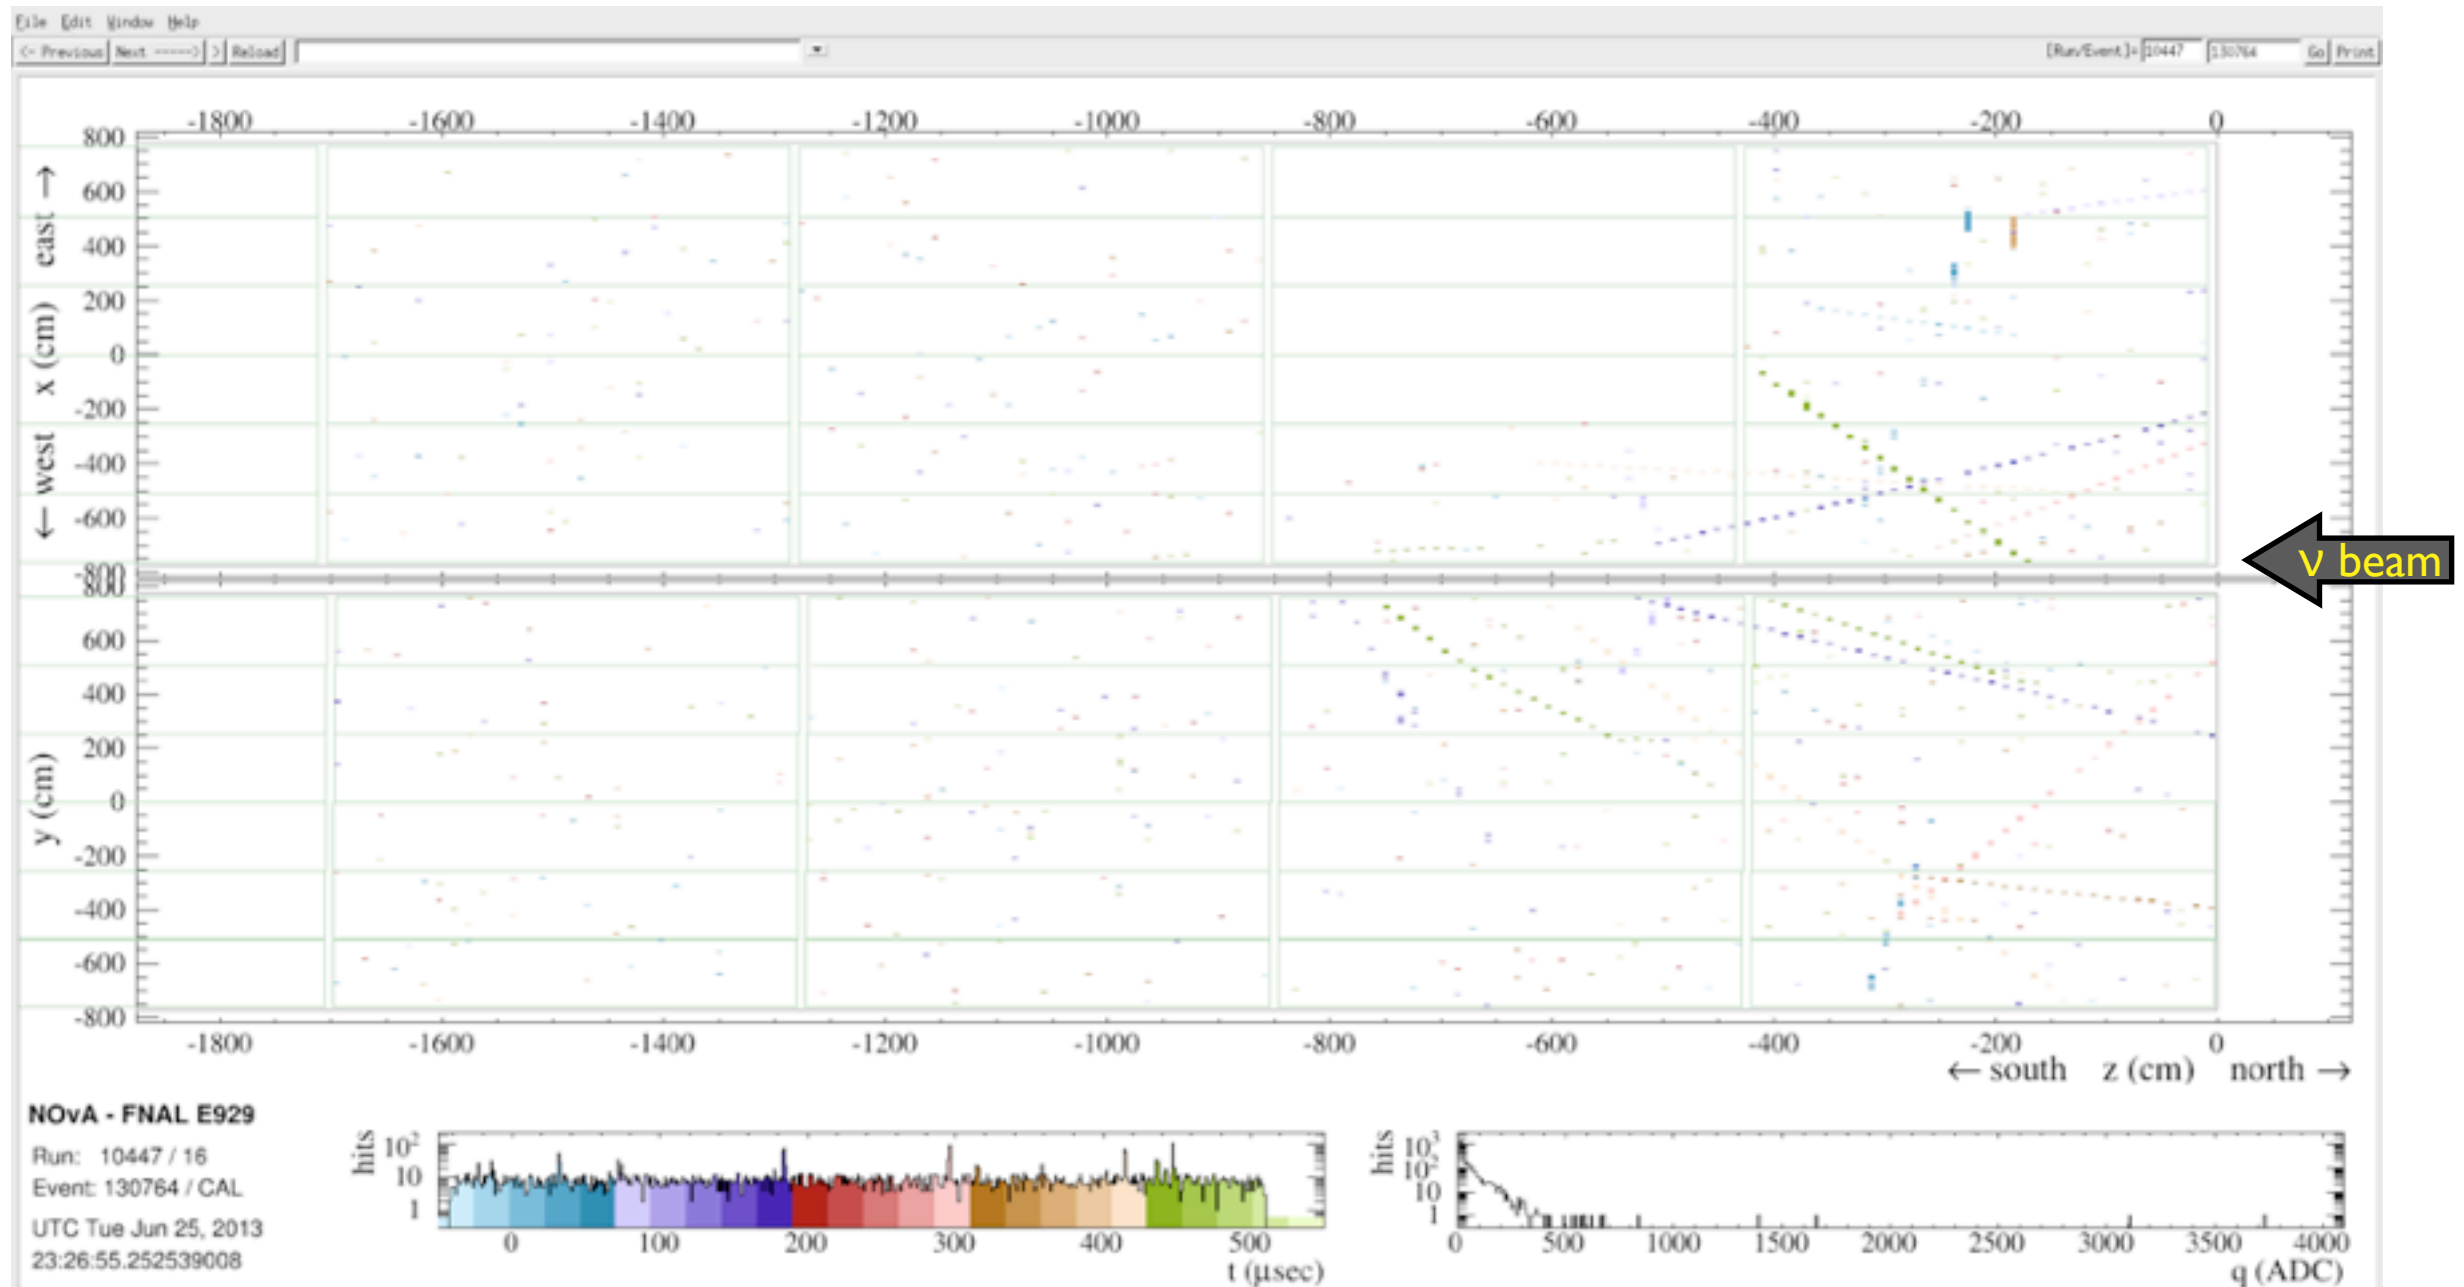
Evidence that training works

FEBs installed

FEBs & APDs installed

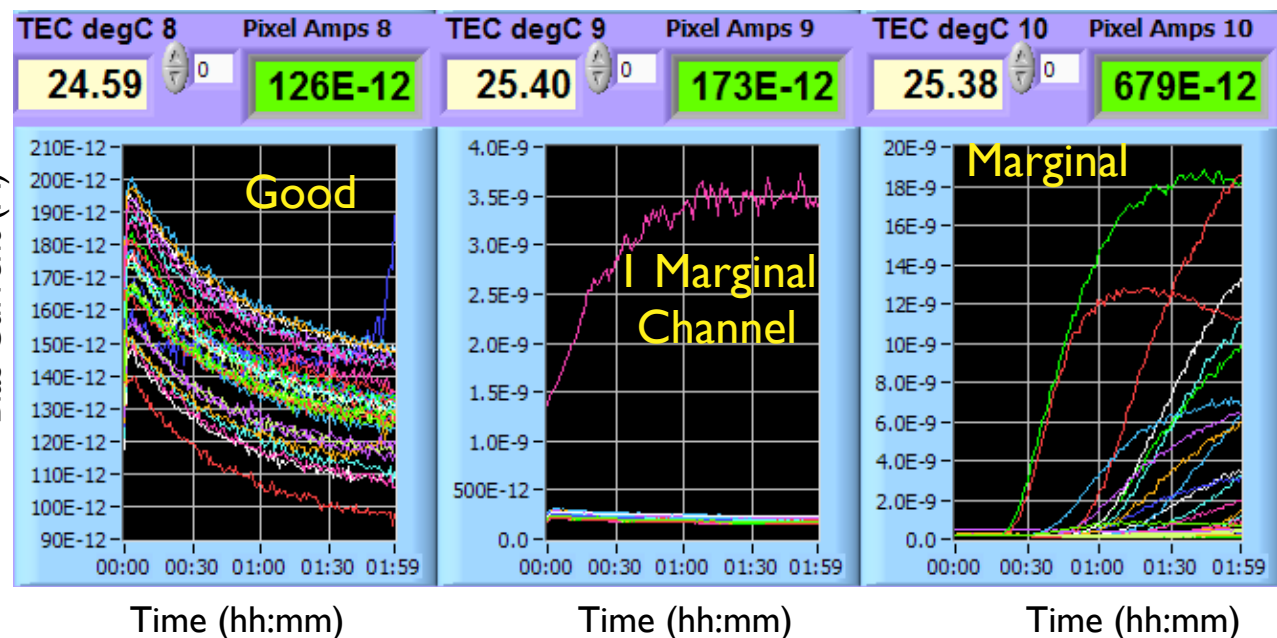
Random APDs from Ash River (2 hr test)

Monitor bias current for longer periods than typical QA tests.

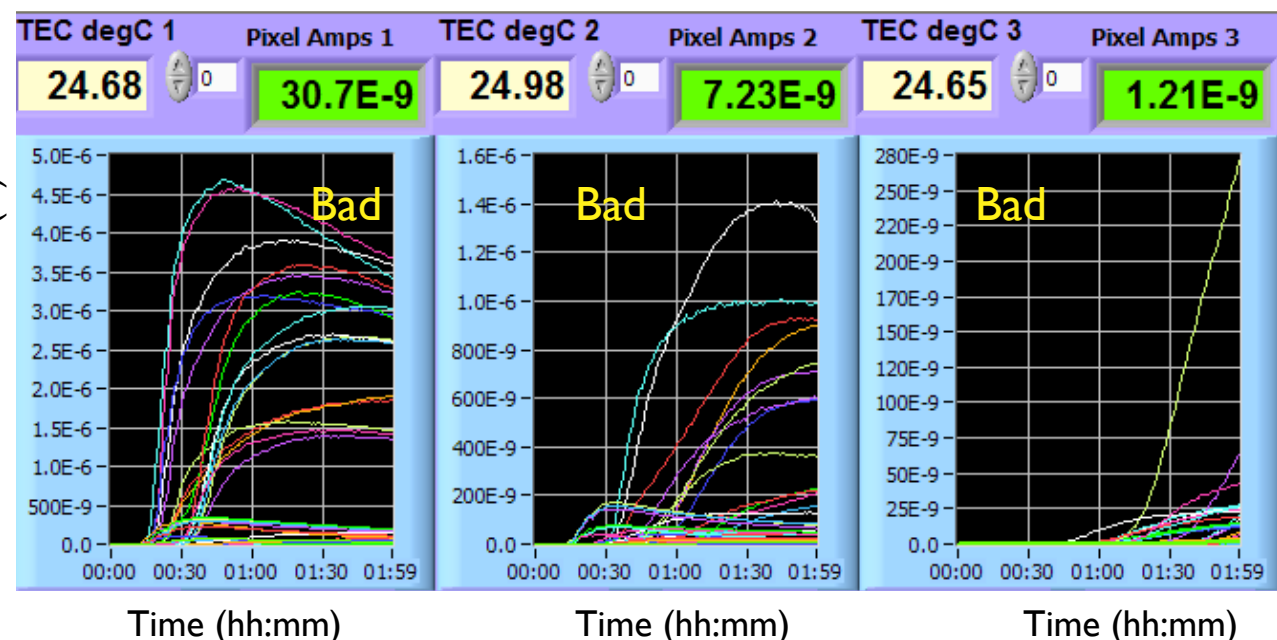
Noisy APDs removed from detector (2 hr test)

- Recently coated (batch 10) show similar problem features to that seen in noisy APDs from the detector
- APDs sitting on shelf at Advanced Coatings behave as new APDs from Hamamatsu
- APDs baked by Advanced Coatings behave as new APDs from Hamamatsu
- Evidence that power cycling a trained APD does not return that APD to a noisy state

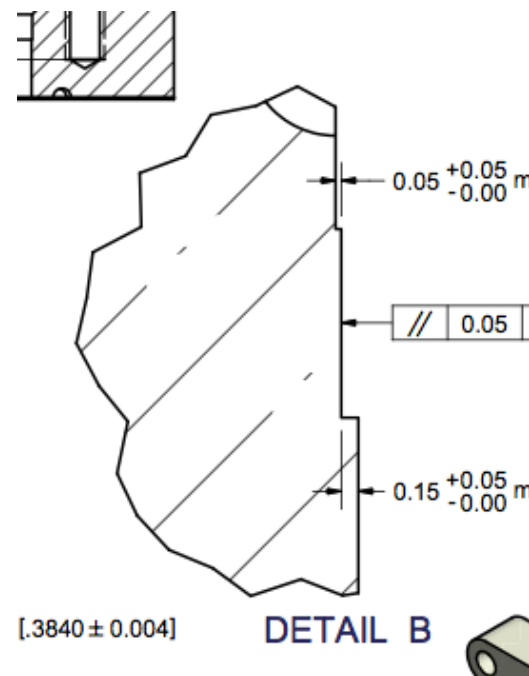
APD Back-off from Optical Bosses

- Carrier Board thickness: 0.0622" +/- 0.0021"
(NOVA-DOC-6412, NDOS)
- Parylene Coating: 0.00045" +/- 0.00007"
(Email from Leon)
- Glue: 0.0032" +/- 0.0024"
(NOVA-DOC-6412, NDOS)
- Built-in "Shim": 0.0059" +/- 0.00197"/0"
(NOVA-DOC-6346)
- PCB back to APD (Gold Bump): ~0.00335" +/- ??(0.00004)
(NOVA-DOC-6474)

Optical boss to coating surface (OBCS) = Shim + Bump – Glue – 2*coating
(Note: The glue shouldn't add to the calculation if contained to glue channel)
OBCS Value with no glue: 0.00825" +/- 0.002"/0.0002"
OBCS Value with glue: 0.0052" +/- 0.003"/0.0024"

Conclusion: If the parts are in spec, mechanical interference is highly unlikely.
(Do we have recent measurements of the part dimensions?)

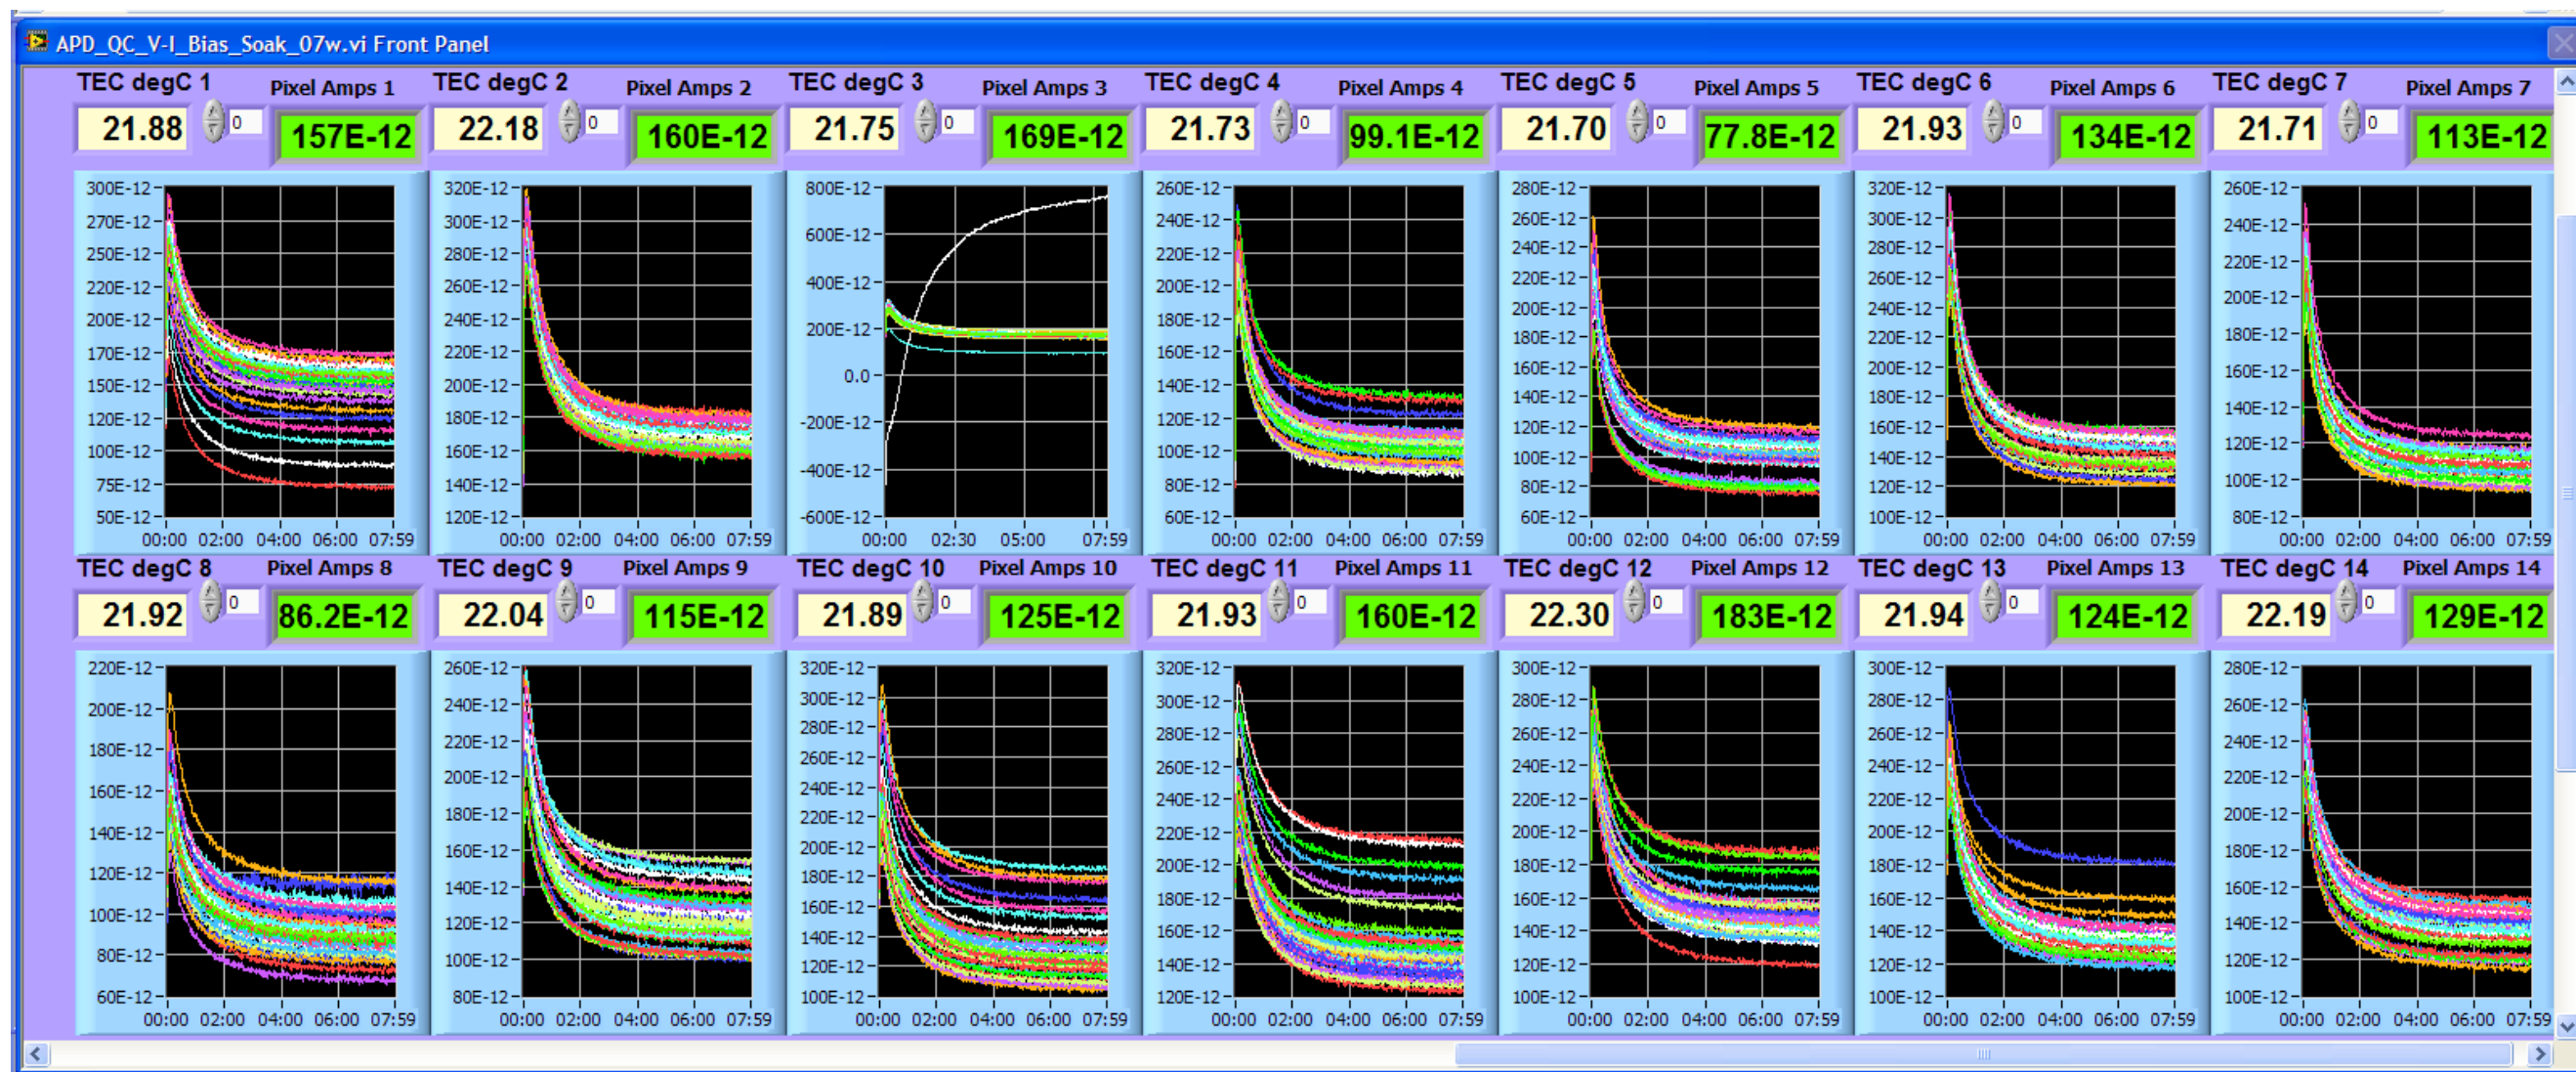
Uncoated Parts from Coater

Sample of 1st 14 look perfect in 8 hr test

Instrumentation problem in 3rd plot top row

Performance similar to Hamamatsu uncoated parts

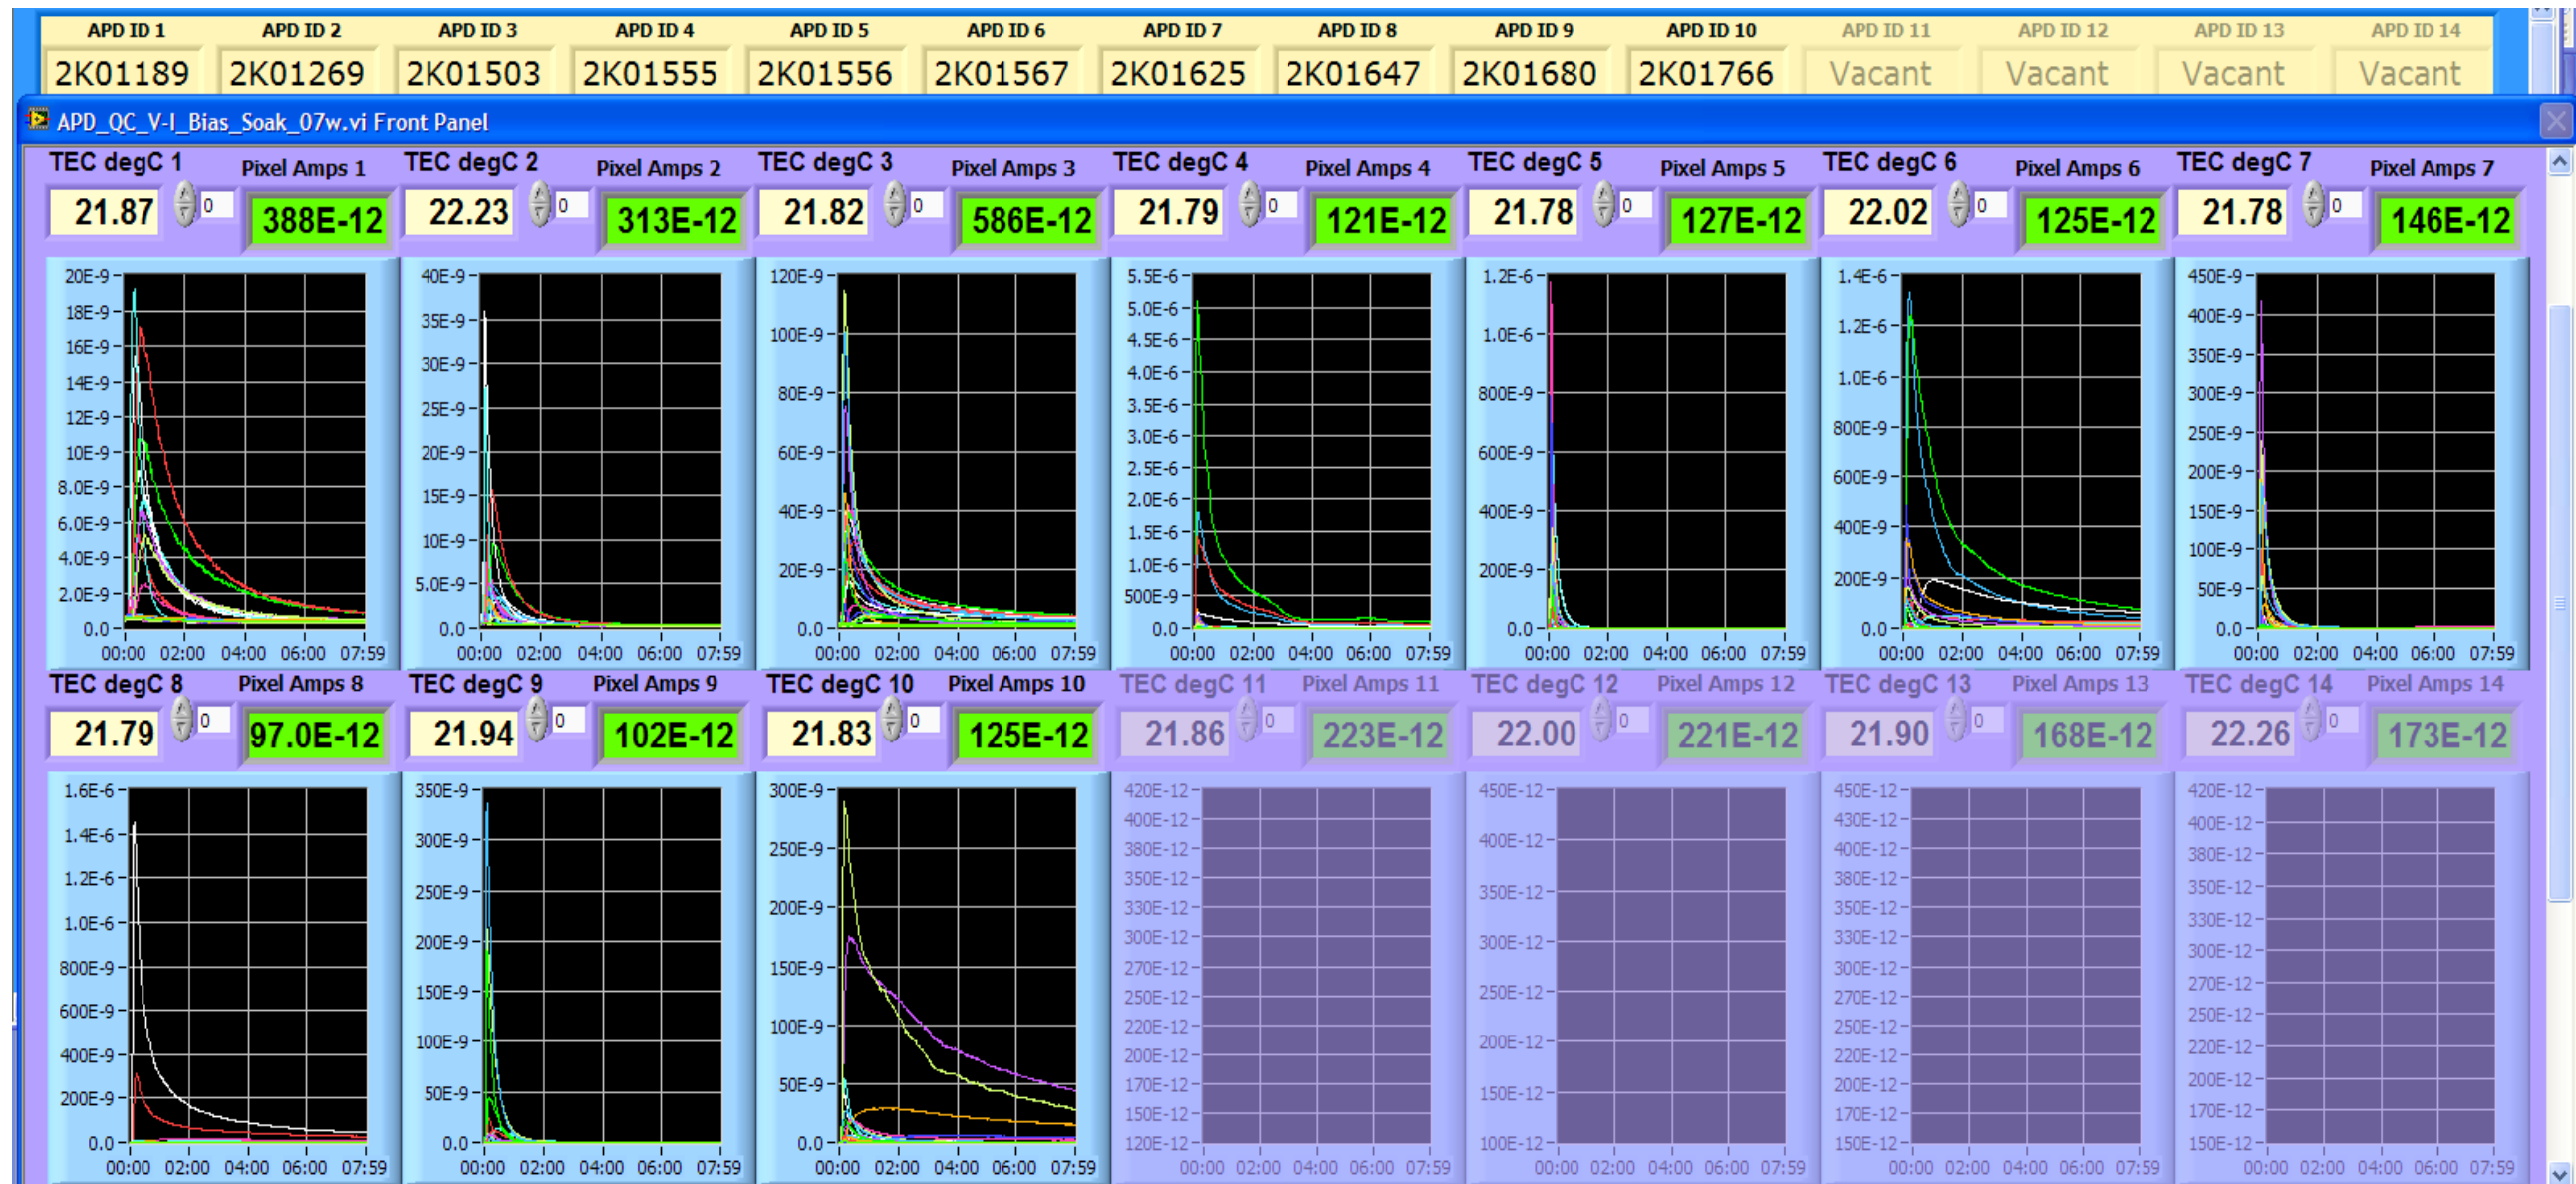
Uncoated Parts from Early Coating Batches

All show high early currents that decay away

Several $> 1 \mu\text{A}$, several $> 100 \text{nA}$

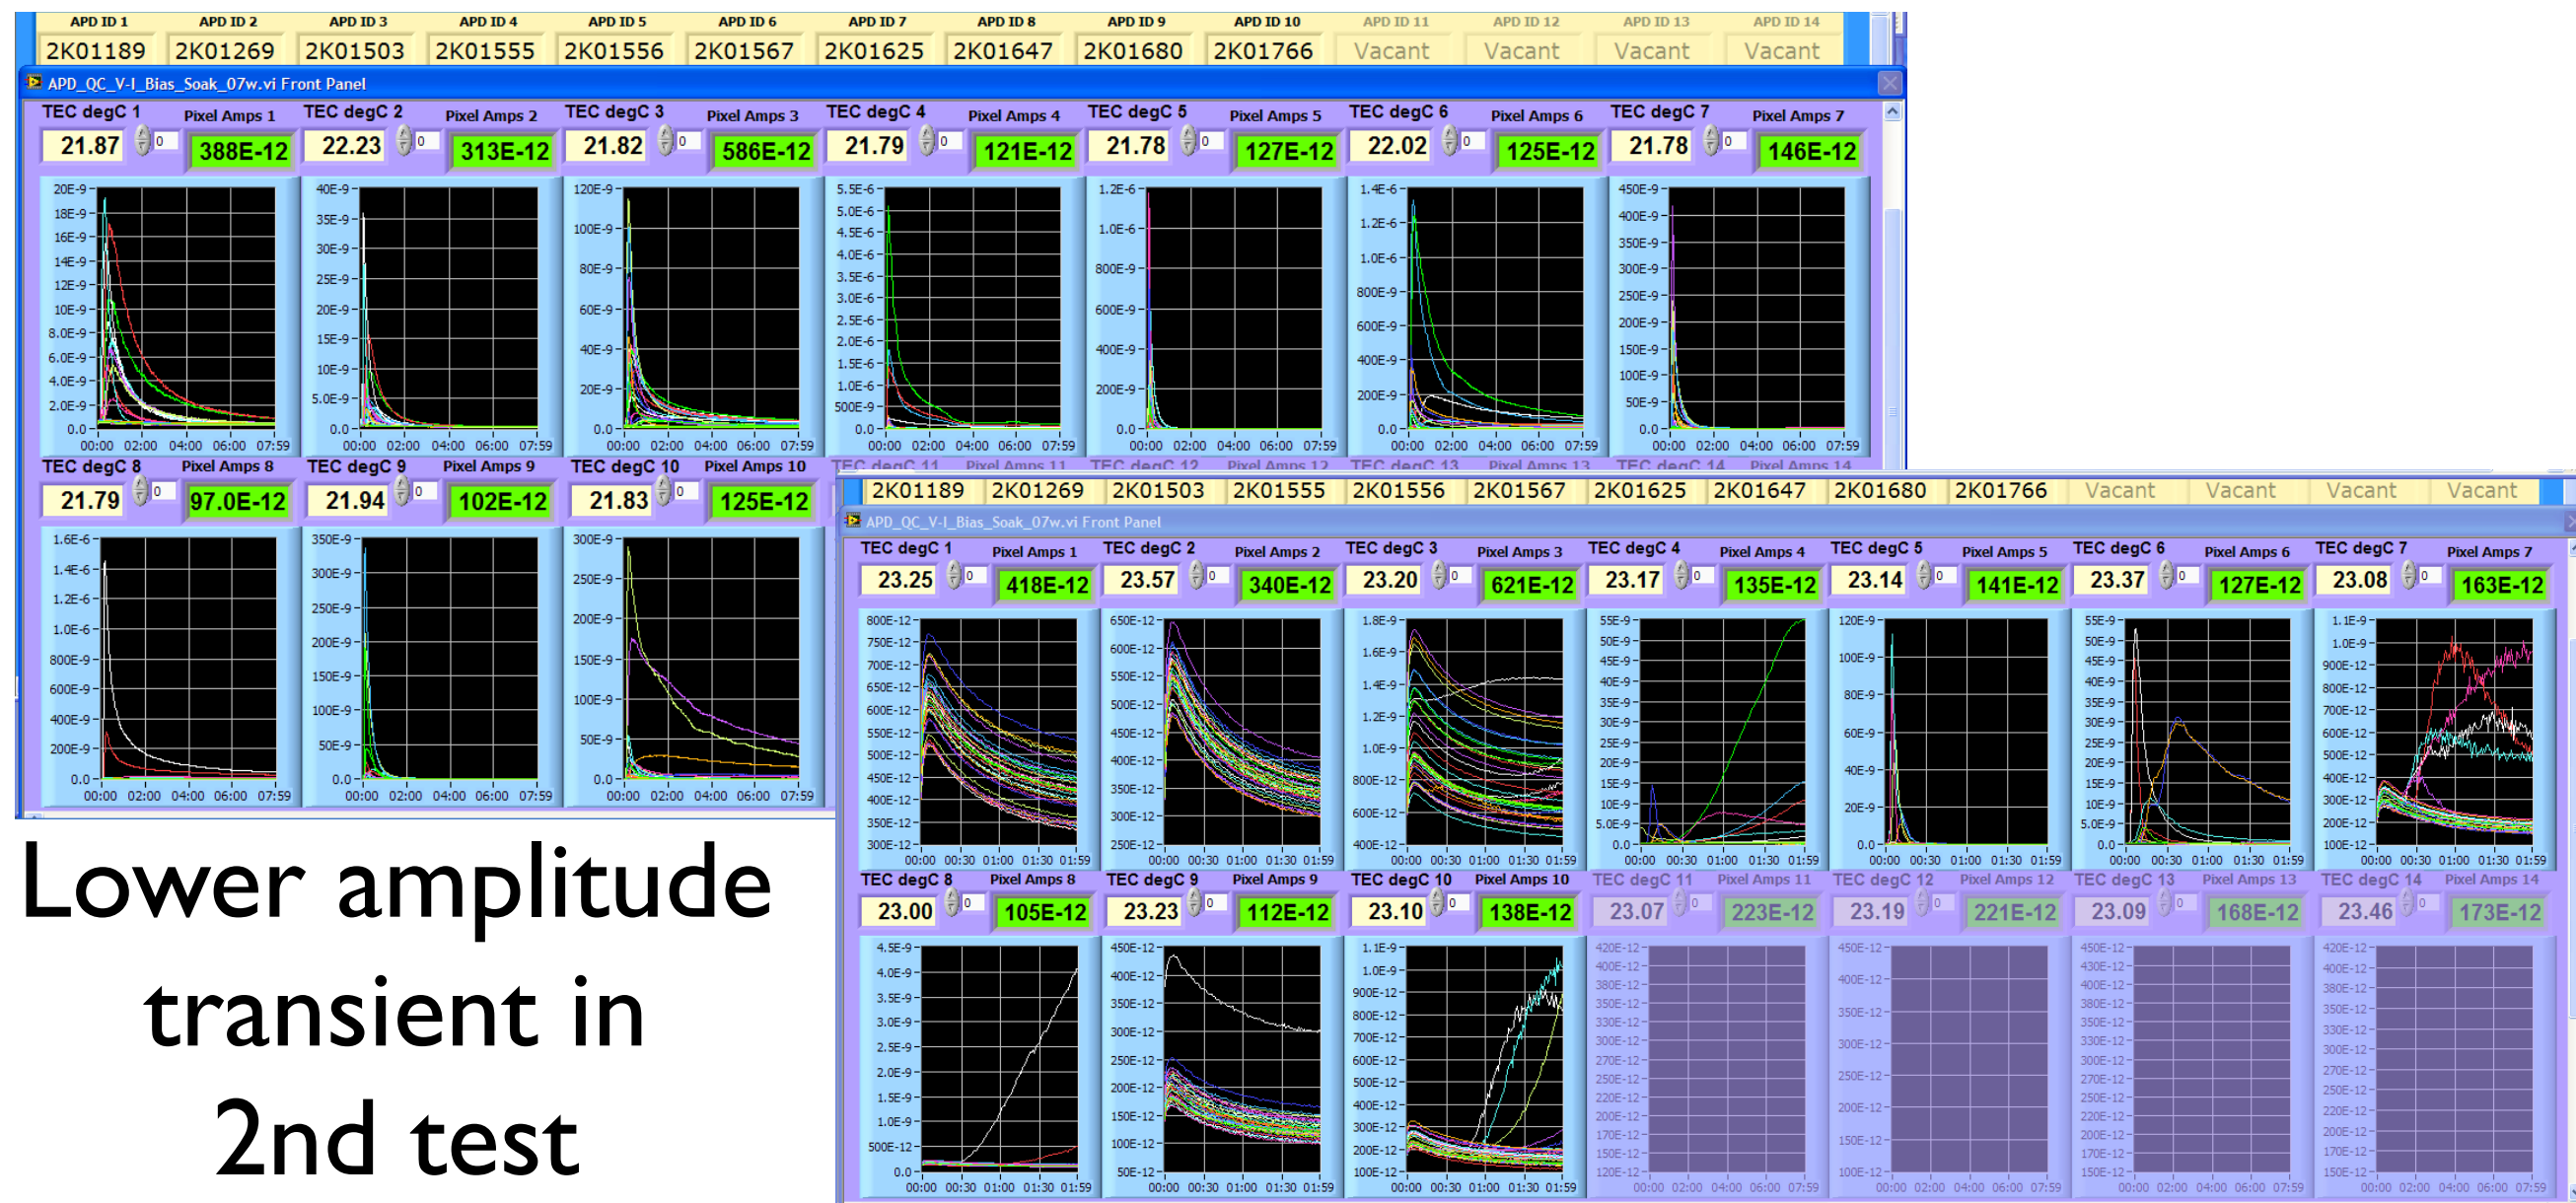
Power Cycle Tests

Lower amplitude
transient in
2nd test
